# Assessment of Dam Safety

## Coal Combustion Surface Impoundments (Task 3)

Dayton Power &  
Light Company

JM Stuart Station

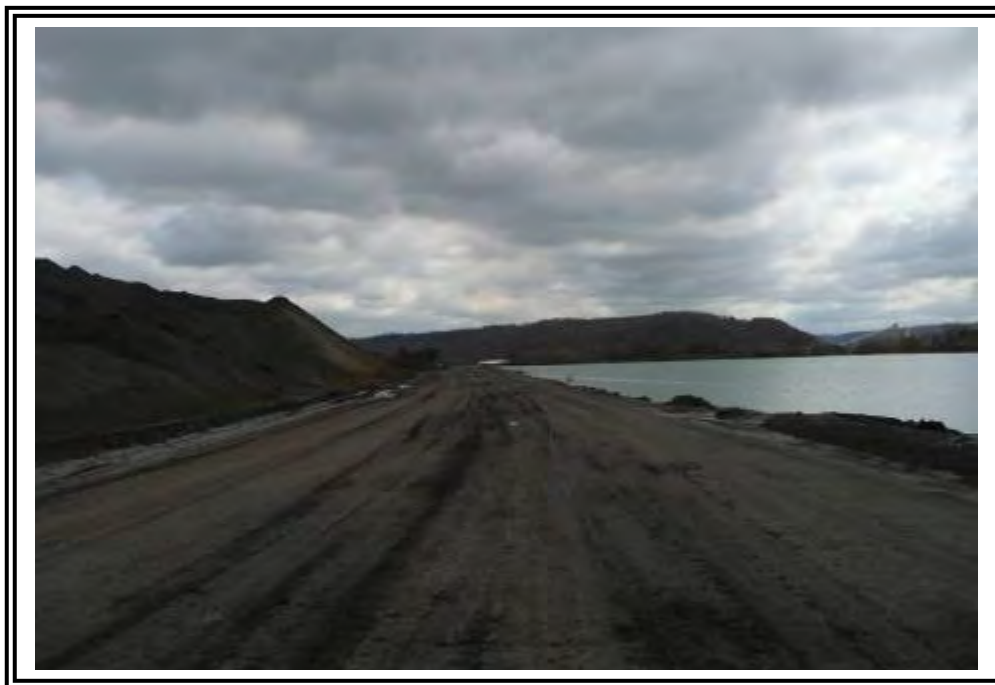
100

Pond 6 and Pond 7/A separator dike looking east showing open water in Pond 7/A on right and ash processing in Pond 6 on left.
